<u>Preliminary Assessment – Mass Central Rail Trail Belchertown Segment</u> from Springfield Road to Route 181

On August 13 & 14, 2019, Conservation Works LLC inspected the 3.2 miles of railroad right-of-way between Springfield Road and Route 181 in Belchertown as a potential addition to the Mass Central Rail Trail (MCRT). Following is our preliminary evaluation of the issues and potential of this route as a key part of the proposed Northampton-to-Boston route.

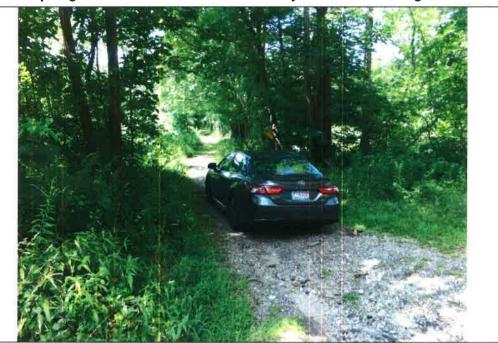
<u>Springfield Road and Route 181 end points</u>. The end point at Springfield Road connects with the next section of right-of-way to the north. At the beginning of that section there is room for one vehicle to park (photo 1), but little or no space to provide for additional future parking. Parking is available approximately 500 feet up Springfield Road for those willing to walk or bike along the paved road to the rail trail.

Photo 1. On the northwest side of Springfield Road the old rail bed continues northwest. There is room for one car to park here next to the pavement. Additional parking is available approximately 500 feet up Springfield Road. The photo shows the next section of right-of-way, which continues to the northwest.

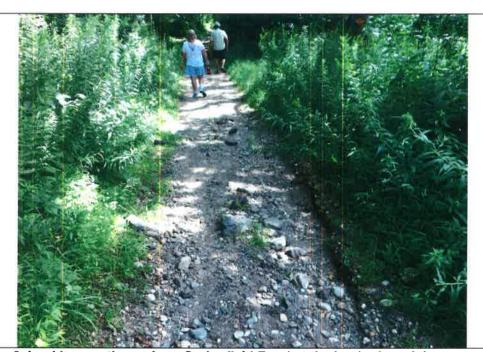
- At the northwest end of the route, stormwater flow from Springfield Road enters the trail and has caused erosion along the first part of the trail (photo 2). Re-directing this surface water to keep it from flowing onto the trail would prevent future trail erosion and deterioration.
- A short distance down the first section of the trail, intermittent stream flow crosses the trail and should be culverted beneath the trail.
- Two existing culverts beneath the trail approximately 10 feet long and 16 inches in diameter have filled with sediment and should be cleaned out to restore the function of the culverts.

Photo 2. Looking southeast from Springfield Road at the beginning of the route. Road runoff has eroded some of the surface of the trail in this section. The right-of-way here would accommodate a 10-foot wide travel surface plus two 2-foot grassed berms at either side.

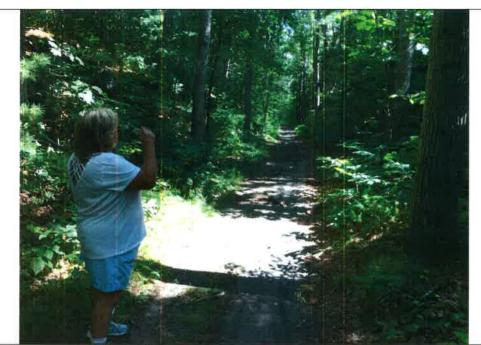
Photo 3. Trees like the red oak at right that are close to the proposed travel surface will probably have to be removed to keep the roots from disturbing the level gravel surface. Ideally, to make the surface appropriately suitable for wheelchair and bicycle travel, 4 inches of graded base would be underlain by 6-12 inches of gravel.

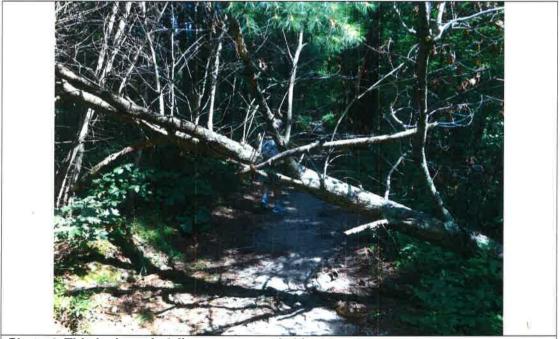
Photo 4. This is the only fallen tree currently blocking the route.

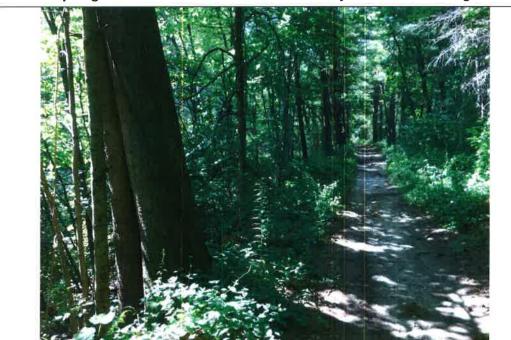
Photo 5. The drop-off on both sides of the trail in this section might make a 2-foot grassed shoulder impractical here and in a few other locations along the right-of-way.

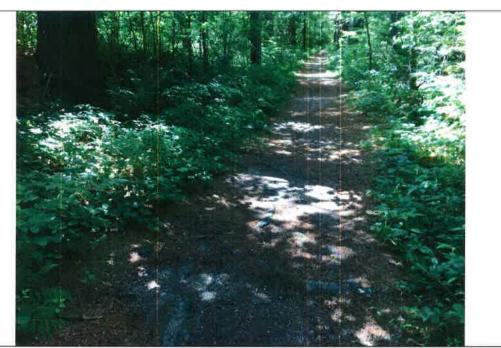
<u>Current surface</u>. At present the route has a roughly 4-foot wide gravel travel surface that is generally smooth and level enough to accommodate most bicycle and pedestrian use (see attached photographs). To meet current standards for an accessible, shared-use path, the trail would be greatly improved by the installation of 10-12 foot wide surface consisting of an underlying gravel base 8-12 inches thick with a 4-inch deep, 3/8"-minus compacted stone aggregate surface on top with 2-foot wide, grassed shoulders. Scattered protruding roots (photo 7) and rocks would need to be removed.

Photo 7. Tree roots that are raised above the present travel surface would have to be removed to allow installation of a gravel base and provide a stable trail bed. This section is a short distance northwest of the North Washington Street crossing.

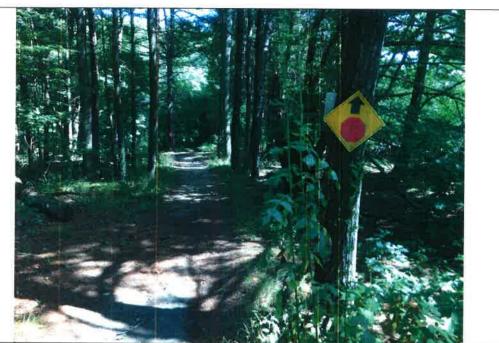
<u>Signs</u>. Currently, there is a handful of signs along the route. Photo 11 shows a sign warning users that they are nearing a stop sign, seen in the distance and shown again in photo 12 at the top of the steep grade down to North Washington Street. In photo 16 is a "no wheeled vehicles" sign. At photo 19 is a sign reading "snowmobile permits required" signed by the Belchertown Snowmobile Club. Photo 21 shows two directional

Photo 11. This warning sign is near the North Washington Street crossing. The trail turns left to drop down to the road. The original rail route continued straight from this point to a railroad bridge that no longer exists.

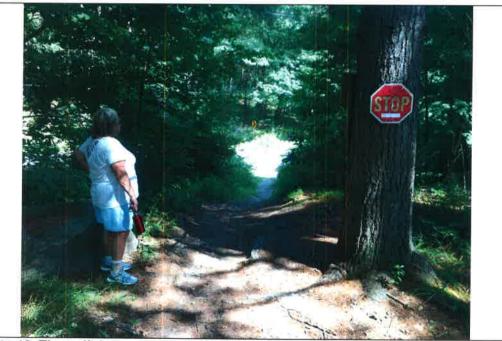
North Washington Street crossing. The trail crosses North Washington Street at a dangerous point with less than 100 feet visibility, tight curves in each direction, the active railroad bridge a few feet to the south, and steep drops to the street on both sides (photos 12-15, 30-32). Given the safety issues connected with an "at grade" crossing here, CW suggests an engineering study to evaluate the best and least expensive means to bridge this road at the railbed elevation. It is hard to imagine a safe way to cross the road here, and the drop in elevation would require the construction of costly switch-backs to comply with ADA accessibility standards.

Photo 12. The trail drops steeply to North Washington Street from this point. Even if a switchback might allow a gradual, wheelchair-appropriate descent to the road, the crossing is in a dangerous location. If at all possible, a bridge over the road at the site of the original bridge would be preferable.

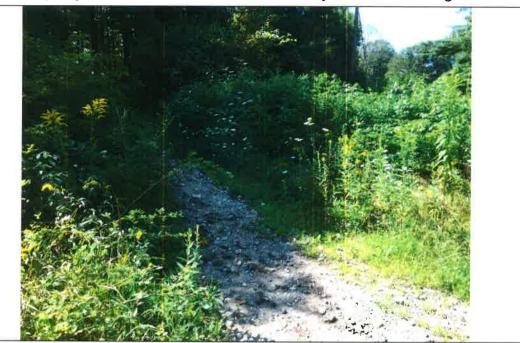
Photo 13. Looking up the slope of the current trail from North Washington Street. The active railroad bridge over the road is downhill out of the photo to the left.

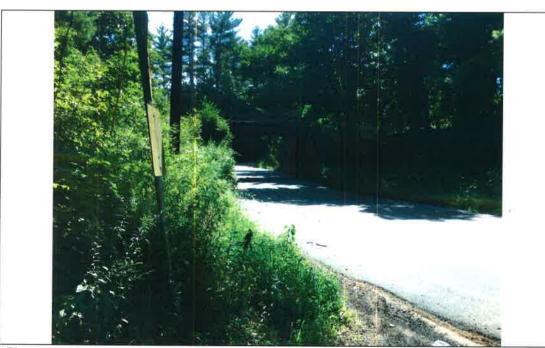
Photo 14. View of the active railroad bridge. Just beyond the narrow section of road beneath the bridge is a sharp left turn, making a pedestrian crossing here a risky proposition.

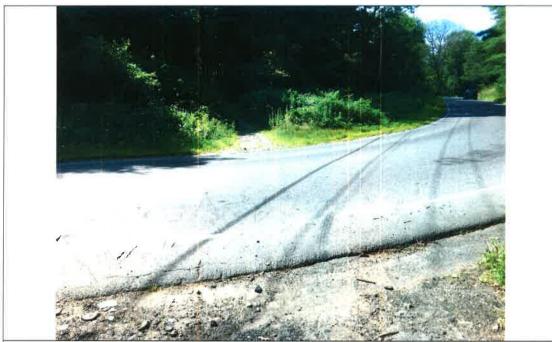
Photo 15. Looking across North Washington Street at the current trail crossing. Curves in both directions make visibility for automobiles quite poor.

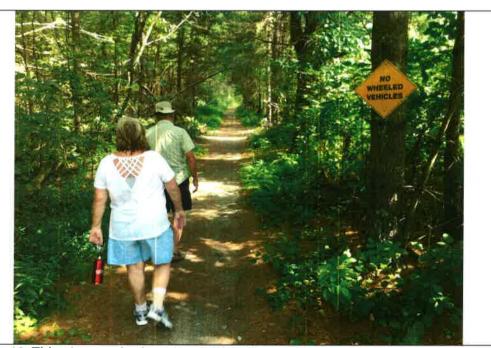
Photo 16. This sign not far from North Washington Street can be interpreted to prohibit bicycles or wheelchairs. Clear regulations will need to be part of any upgrading of the trail.

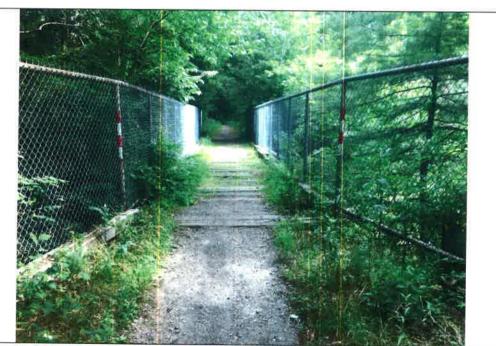
<u>Jabish Brook bridge</u>. Photos 22-24 show the timber railroad bridge over Jabish Brook, over which the trail crosses. It appears to be sound but an assessment by a structural engineer is warranted before plans to use the structure as part of the MCRT are proposed.

Photo 22. This old railroad bridge over Jabish Brook appears to be in good enough condition to accommodate pedestrian traffic and maintenance equipment.

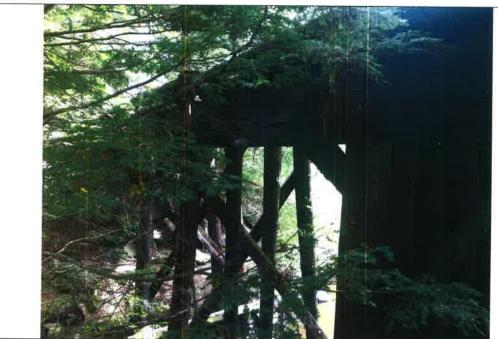
Photo 23. The support structure of the Jabish Brook bridge seen from beneath. An engineer's assessment should be undertaken to be certain of the bridge's condition.

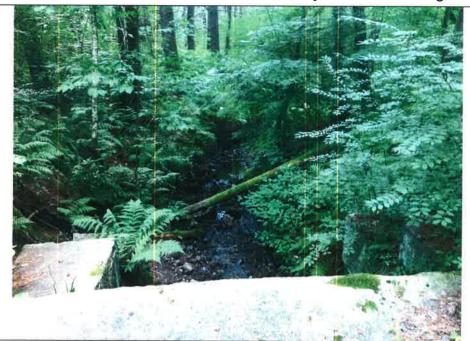
<u>Stone culvert</u>. Photo 25 shows a substantial stone culvert beneath the rail trail in the southern section of the route. The culvert appears to be in good condition.

Photo 25. Not far from Route 181 is this stone culvert, which appears to be in good condition.

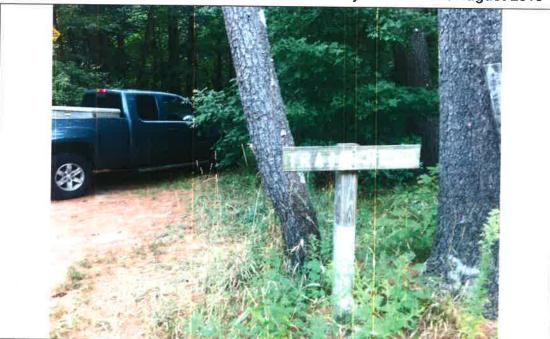
At the southern end point at Route 181 (Franklin Street), there is room for 2 or 3 vehicles to park next to an impromptu "trail head" sign (photo 29). This spot could potentially be provided with a more formal gravel parking area that could accommodate additional vehicles.

Photo 29. This trailhead sign is located at Route 181. Limited parking is available here, and future parking improvements could probably accommodate as many as 4 cars. The truck in the photo belongs to a runner who frequently uses the trail.

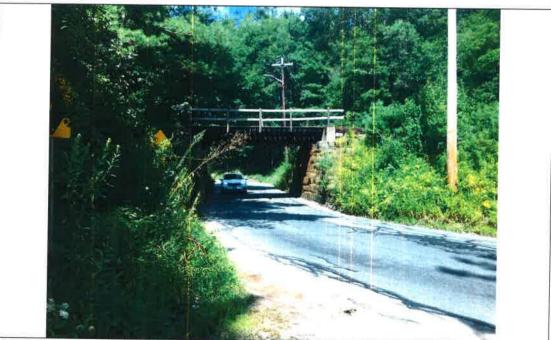
Photo 30. View of the North Washington Street railroad bridge and its stone abutments from the south. This bridge has a 30-foot span, but because there are no existing abutments for an adjacent, future rail trail bridge, its span would need to be 50 to 80 feet in length. A fiberglass pedestrian bridge might be the best option here.

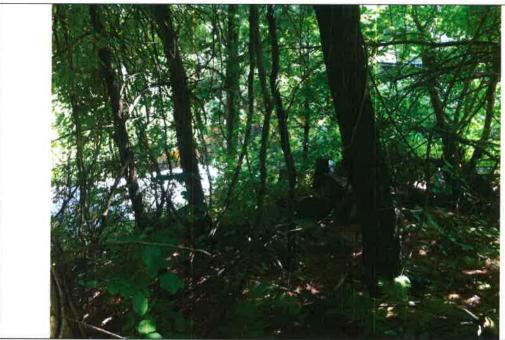
Photo 31. View of the high point on the west side of North Washington Street. The paved road can be seen at left and the active railroad bridge is barely visible at the upper right.

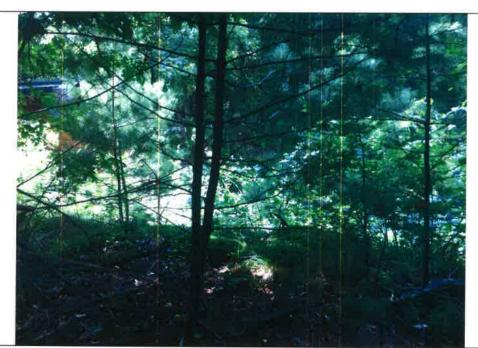
Photo 32. View of the high point on the east side of North Washington Street. The road pavement is barely visible through the trees to the right and the active railroad bridge is at upper left.
