Preliminary Assessment – Mass Central Rail Trail Belchertown Segment from Springfield Road to Route 181

Belchertown Rail Trail Springfield Road to Rt 181 Preliminary Assessment August 2019

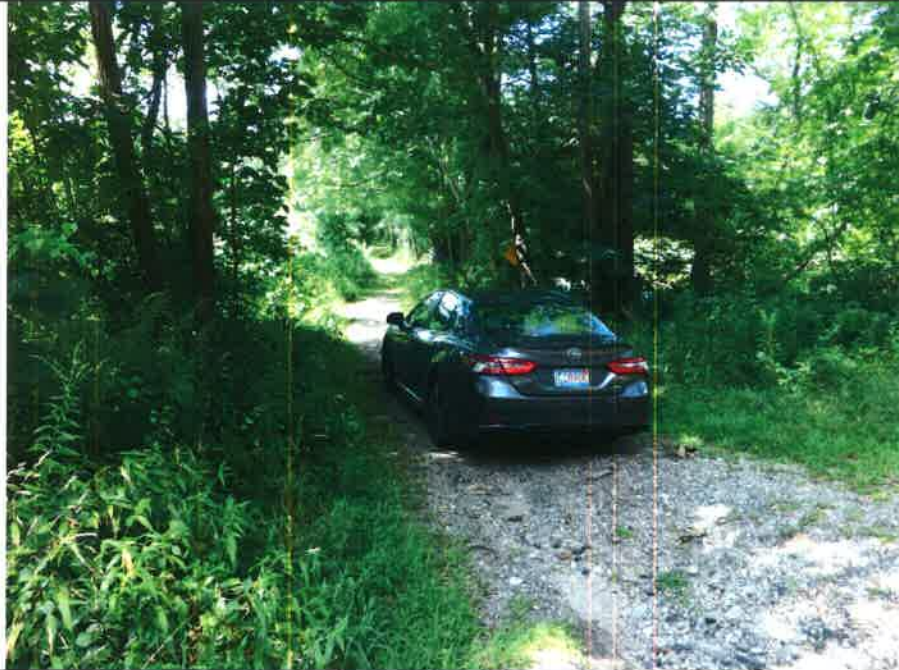
Photo 1. On the northwest side of Springfield Road the old rail bed continues northwest. There is room for one car to park here next to the pavement. Additional parking is available approximately 500 feet up Springfield Road. The photo shows the next section of right-of-way, which continues to the northwest.

Springfield Road and Route 181 end points. The end point at Springfield Road connects with the next section of right-of-way to the north. At the beginning of that section there is room for one vehicle to park (photo 1), but little or no space to provide for additional future parking. Parking is available approximately 500 feet up Springfield Road for those willing to walk or bike along the paved road to the rail trail.

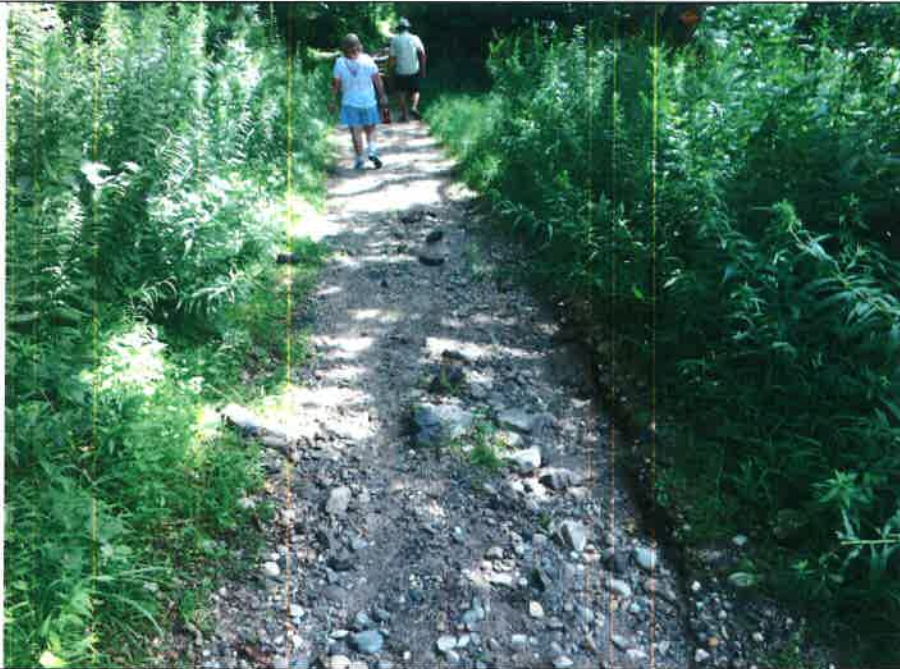
Photo 2. Looking southeast from Springfield Road at the beginning of the route. Road runoff has eroded some of the surface of the trail in this section. The right-of-way here would accommodate a 10-foot wide travel surface plus two 2-foot grassed berms at either side.

- At the northwest end of the route, stormwater flow from Springfield Road enters the trail and has caused erosion along the first part of the trail (photo 2). Re-directing this surface water to keep it from flowing onto the trail would prevent future trail erosion and deterioration.
- A short distance down the first section of the trail, intermittent stream flow crosses the trail and should be culverted beneath the trail.
- Two existing culverts beneath the trail approximately 10 feet long and 16 inches in diameter have filled with sediment and should be cleaned out to restore the function of the culverts.

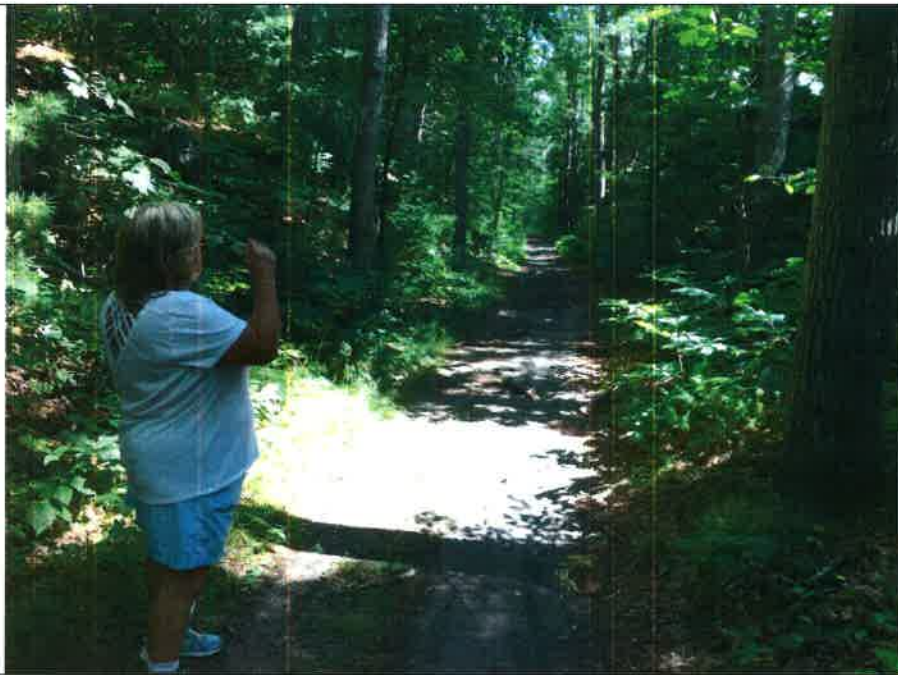
Photo 3. Trees like the red oak at right that are close to the proposed travel surface will probably have to be removed to keep the roots from disturbing the level gravel surface. Ideally, to make the surface appropriately suitable for wheelchair and bicycle travel, 4 inches of graded base would be underlain by 6-12 inches of gravel.

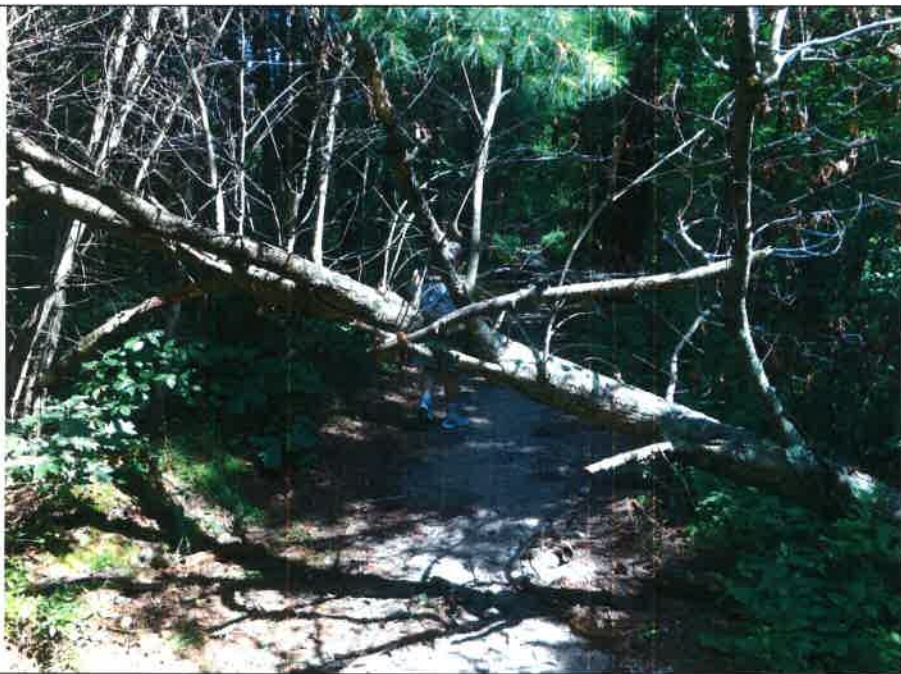
Photo 4. This is the only fallen tree currently blocking the route.

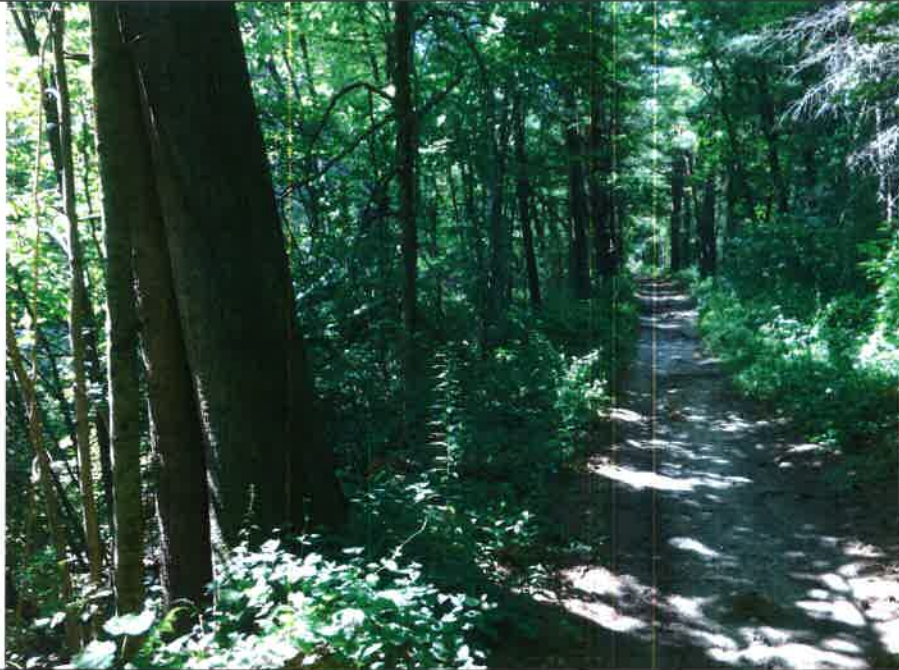
Photo 5. The drop-off on both sides of the trail in this section might make a 2-foot grassed shoulder impractical here and in a few other locations along the right-of-way.

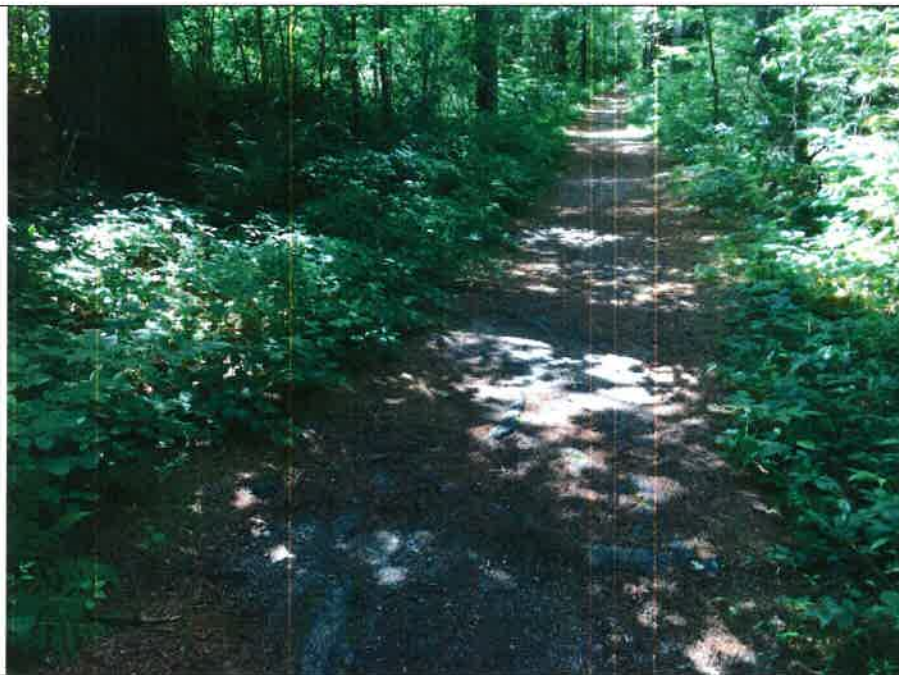
Photo 7. Tree roots that are raised above the present travel surface would have to be removed to allow installation of a gravel base and provide a stable trail bed. This section is a short distance northwest of the North Washington Street crossing.

Current surface. At present the route has a roughly 4-foot wide gravel travel surface that is generally smooth and level enough to accommodate most bicycle and pedestrian use (see attached photographs). To meet current standards for an accessible, shared-use path, the trail would be greatly improved by the installation of 10-12 foot wide surface consisting of an underlying gravel base 8-12 inches thick with a 4-inch deep, 3/8"-minus compacted stone aggregate surface on top with 2-foot wide, grassed shoulders. Scattered protruding roots (photo 7) and rocks would need to be removed.

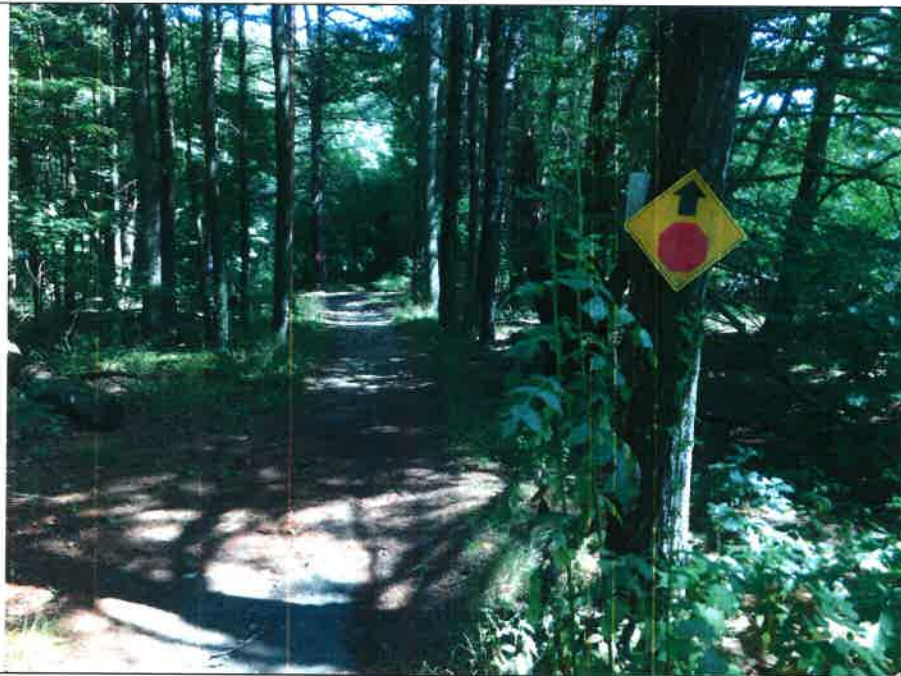
Photo 11. This warning sign is near the North Washington Street crossing. The trail turns left to drop down to the road. The original rail route continued straight from this point to a railroad bridge that no longer exists.

Signs. Currently, there is a handful of signs along the route. Photo 11 shows a sign warning users that they are nearing a stop sign, seen in the distance and shown again in photo 12 at the top of the steep grade down to North Washington Street. In photo 16 is a "no wheeled vehicles" sign. At photo 19 is a sign reading "snowmobile permits required" signed by the Belchertown Snowmobile Club. Photo 21 shows two directional

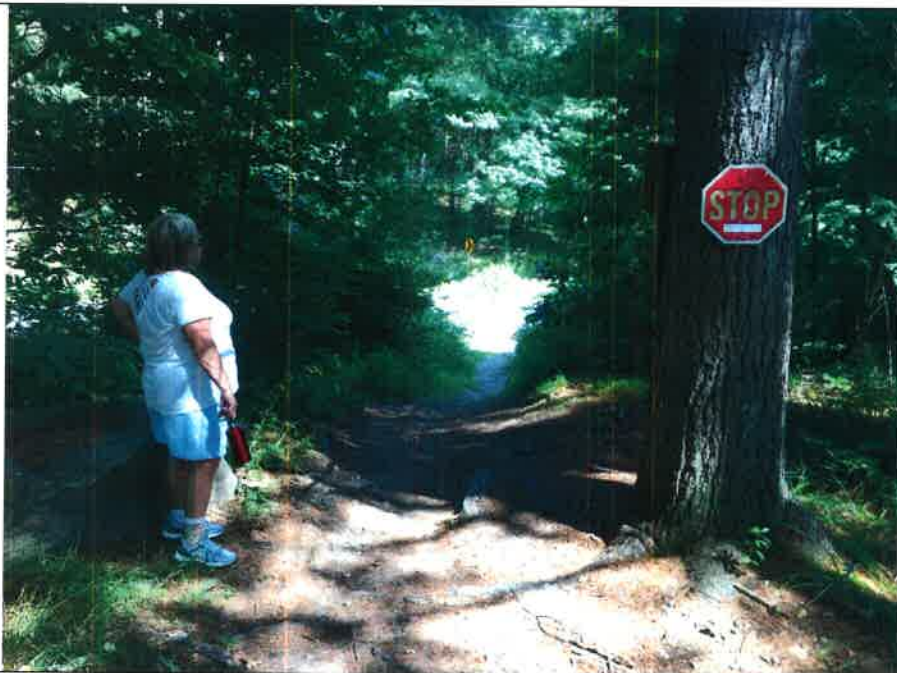
Photo 12. The trail drops steeply to North Washington Street from this point. Even if a switchback might allow a gradual, wheelchair-appropriate descent to the road, the crossing is in a dangerous location. If at all possible, a bridge over the road at the site of the original bridge would be preferable.

North Washington Street crossing. The trail crosses North Washington Street at a dangerous point with less than 100 feet visibility, tight curves in each direction, the active railroad bridge a few feet to the south, and steep drops to the street on both sides (photos 12-15, 30-32). Given the safety issues connected with an "at grade" crossing here, CW suggests an engineering study to evaluate the best and least expensive means to bridge this road at the railbed elevation. It is hard to imagine a safe way to cross the road here, and the drop in elevation would require the construction of costly switch-backs to comply with ADA accessibility standards.

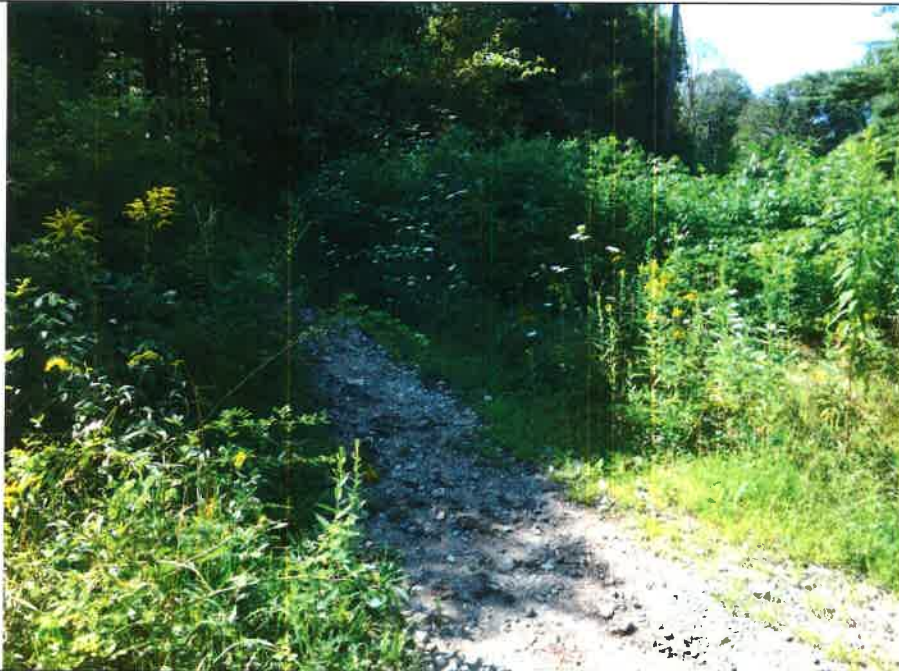
Photo 13. Looking up the slope of the current trail from North Washington Street. The active railroad bridge over the road is downhill out of the photo to the left.

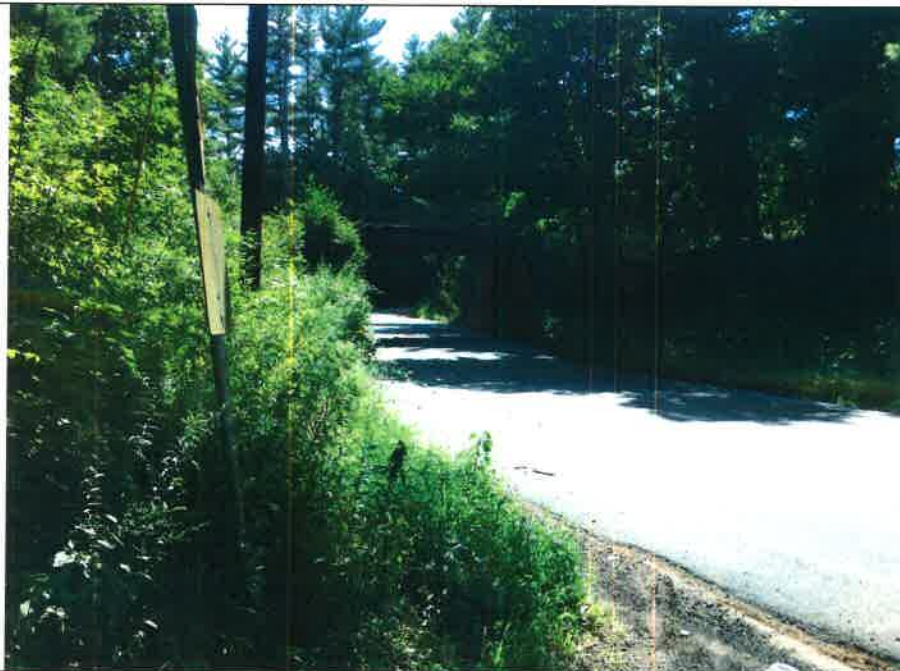
Photo 14. View of the active railroad bridge. Just beyond the narrow section of road beneath the bridge is a sharp left turn, making a pedestrian crossing here a risky proposition.

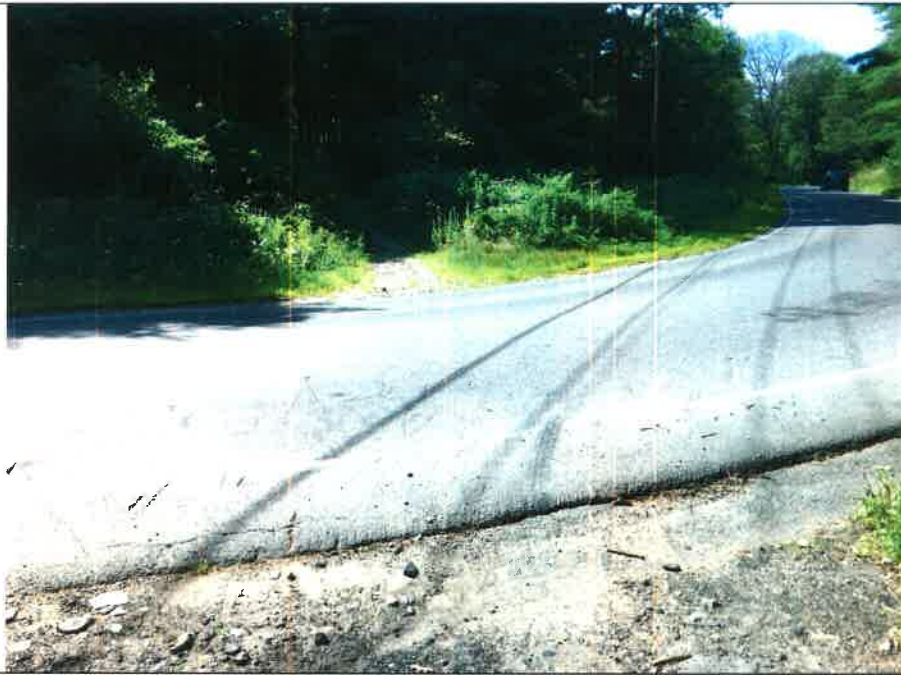
Photo 15. Looking across North Washington Street at the current trail crossing. Curves in both directions make visibility for automobiles quite poor.

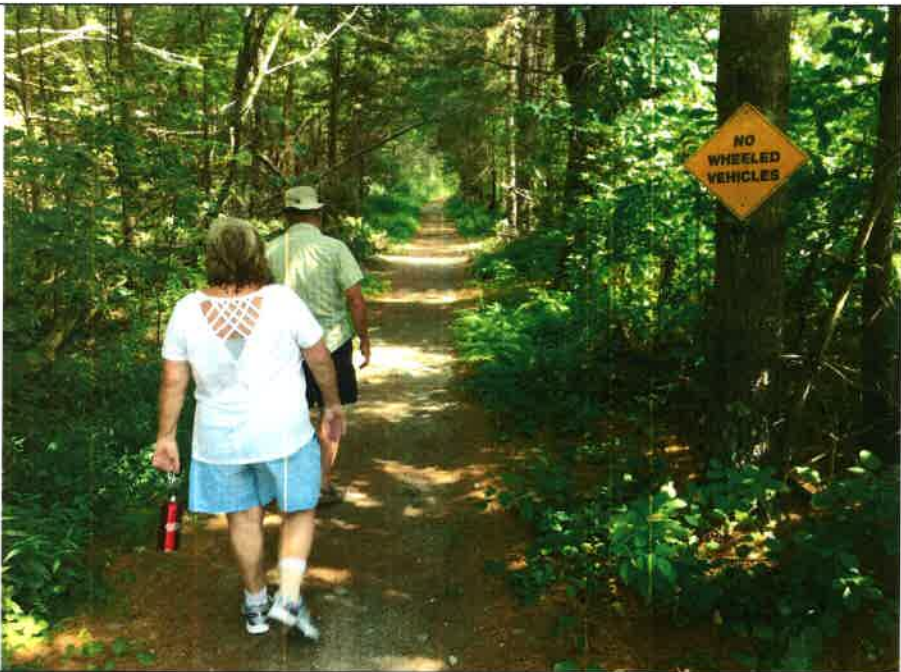
Photo 16. This sign not far from North Washington Street can be interpreted to prohibit bicycles or wheelchairs. Clear regulations will need to be part of any upgrading of the trail.

Regulations. Any planning for future trail development and improvement will need to address allowed and prohibited uses. Horseback riders currently use the trail, although on our inspection of the trail we saw no evidence of recent horse traffic. Future horse use would compromise the graded surface and should probably be prohibited. However, there may be room to install a parallel horse trail along the side of the rail trail surface, a possibility that should be studied before final plans are made. The rural nature of this section of the trail, the horse-owner community of Belchertown, and the value of including as many user groups as possible make it important not to come to a hasty conclusion about this issue. For safety concerns, motorized vehicles should be prohibited and suitable barriers put in place at each potential vehicle access point.

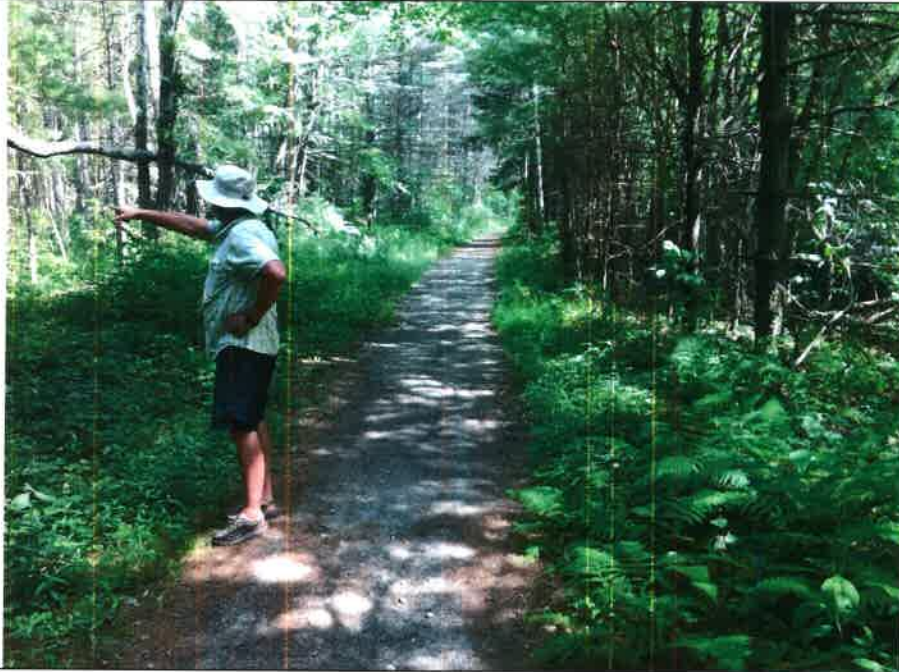
Photo 17. Conservation Commission Vice Chair Jon Clements examines the trail on a recent walk-through. The right-of-way here would safely accommodate a 10-foot wide travel surface and a 2-foot grassy shoulder on each side. There might also be room for a parallel horse trail at one side.

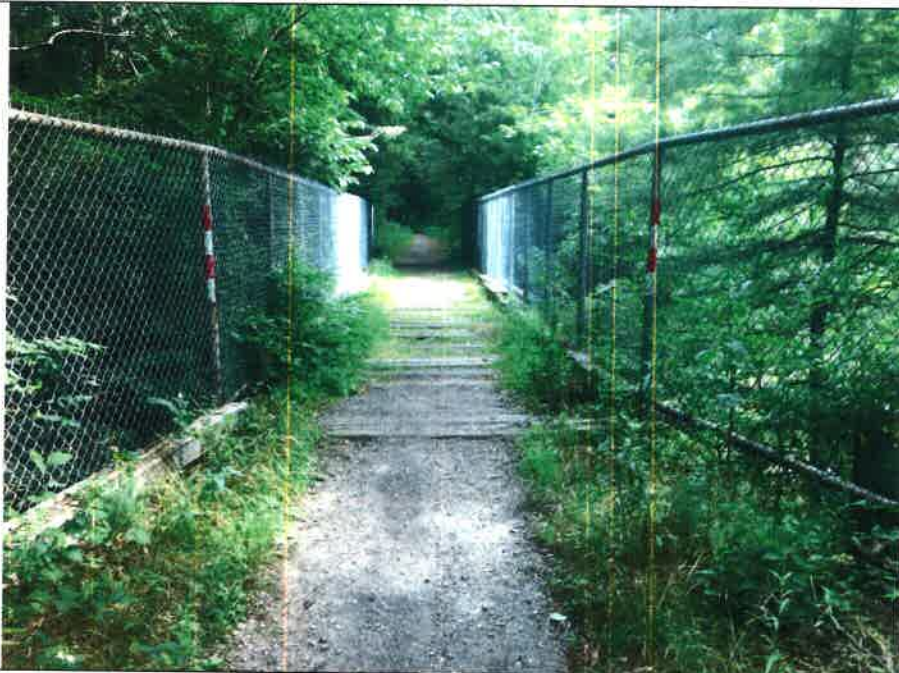
Photo 22. This old railroad bridge over Jabish Brook appears to be in good enough condition to accommodate pedestrian traffic and maintenance equipment.

Jabish Brook bridge. Photos 22-24 show the timber railroad bridge over Jabish Brook, over which the trail crosses. It appears to be sound but an assessment by a structural engineer is warranted before plans to use the structure as part of the MCRT are proposed.

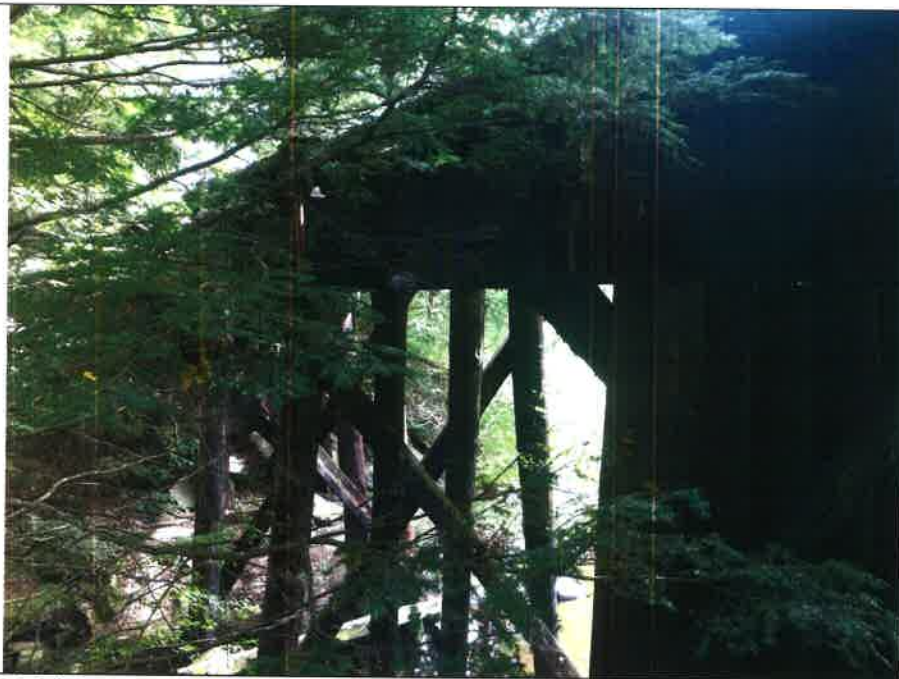
Photo 23. The support structure of the Jabish Brook bridge seen from beneath. An engineer's assessment should be undertaken to be certain of the bridge's condition.

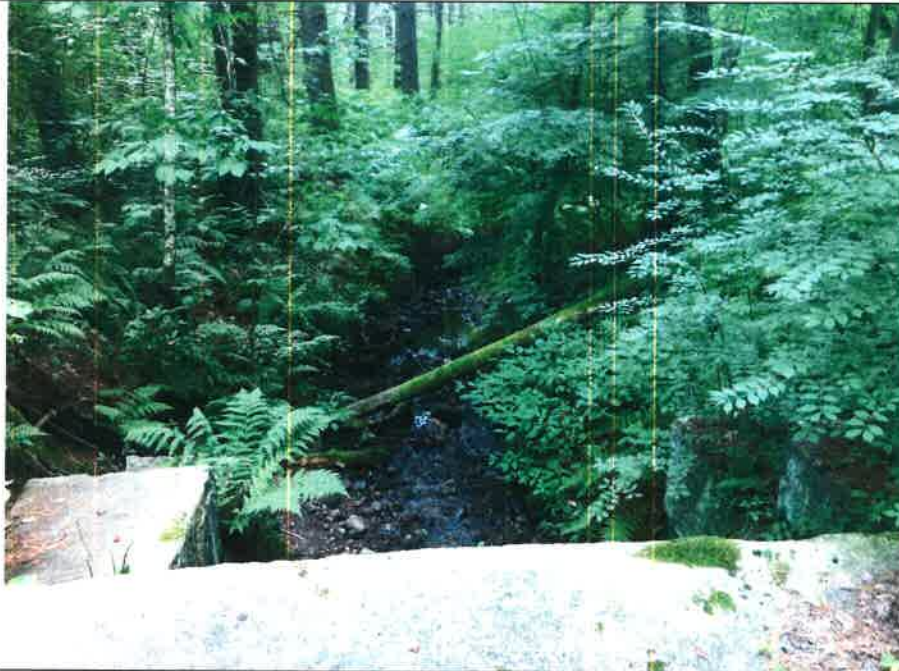
Photo 25. Not far from Route 181 is this stone culvert, which appears to be in good condition.

Stone culvert. Photo 25 shows a substantial stone culvert beneath the rail trail in the southern section of the route. The culvert appears to be in good condition.

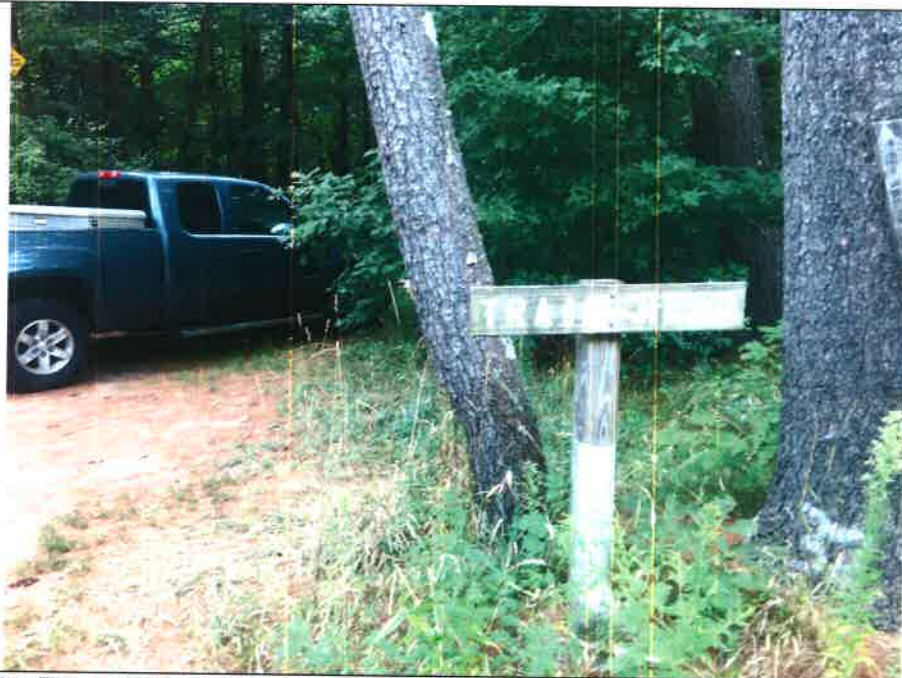
Photo 29. This trailhead sign is located at Route 181. Limited parking is available here, and future parking improvements could probably accommodate as many as 4 cars. The truck in the photo belongs to a runner who frequently uses the trail.

At the southern end point at Route 181 (Franklin Street), there is room for 2 or 3 vehicles to park next to an impromptu "trail head" sign (photo 29). This spot could potentially be provided with a more formal gravel parking area that could accommodate additional vehicles.

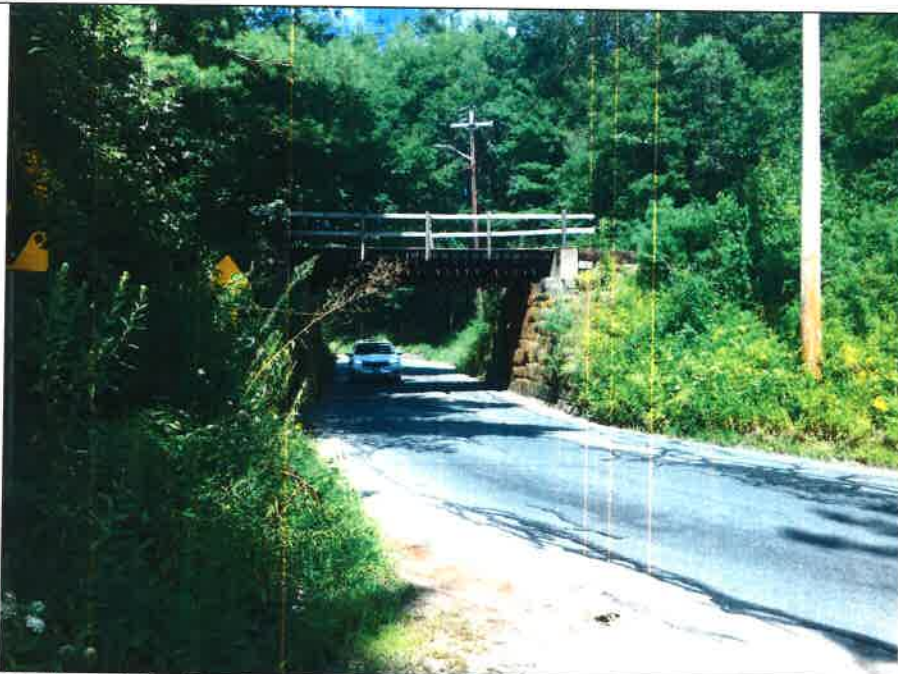
Photo 30. View of the North Washington Street railroad bridge and its stone abutments from the south. This bridge has a 30-foot span, but because there are no existing abutments for an adjacent, future rail trail bridge, its span would need to be 50 to 80 feet in length. A fiberglass pedestrian bridge might be the best option here.

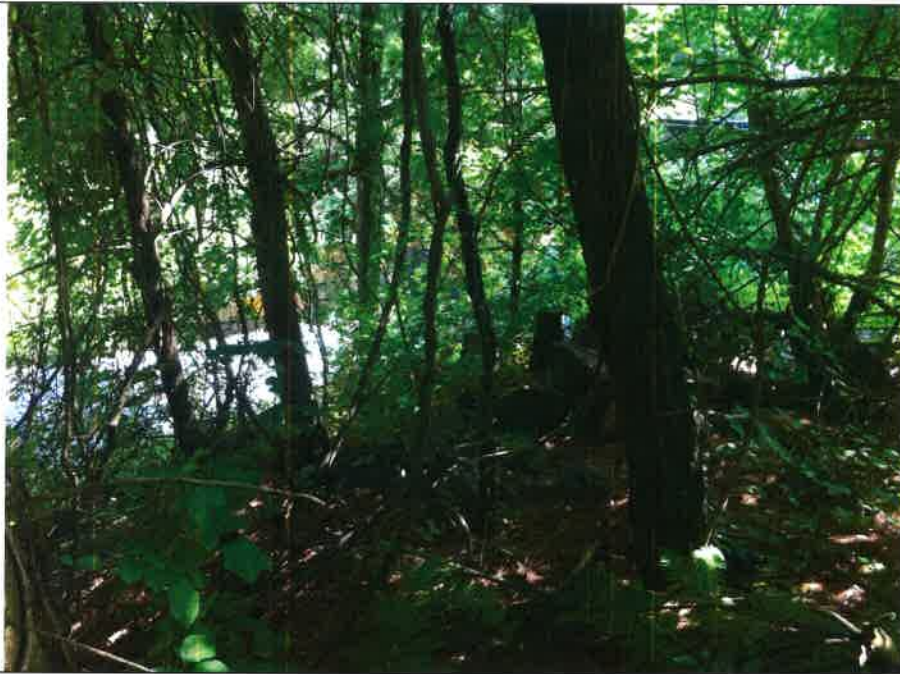
Photo 31. View of the high point on the west side of North Washington Street. The paved road can be seen at left and the active railroad bridge is barely visible at the upper right.

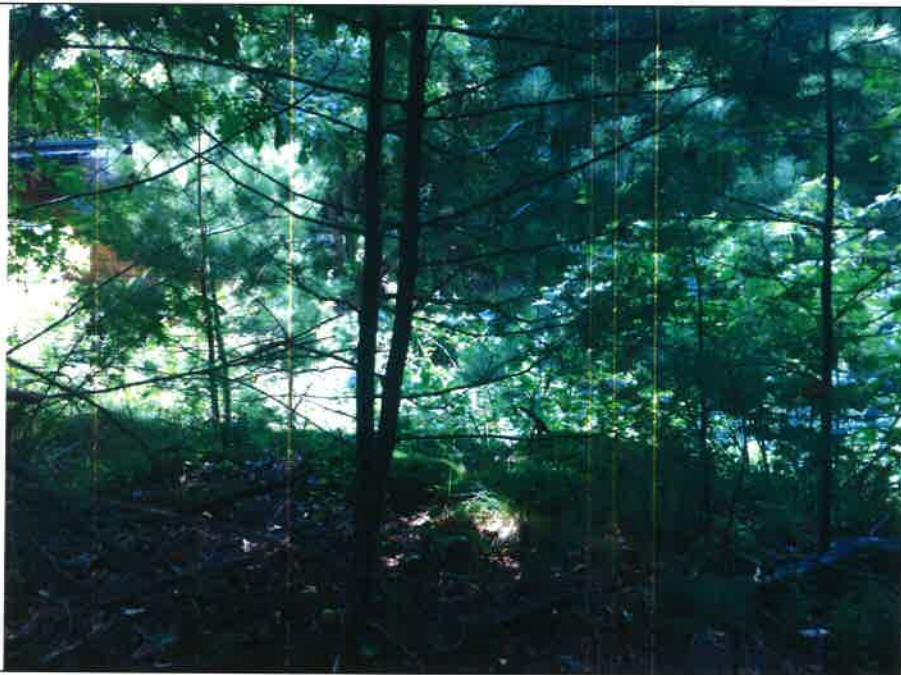
Photo 32. View of the high point on the east side of North Washington Street. The road pavement is barely visible through the trees to the right and the active railroad bridge is at upper left.
